X-Ray Photoelectron Spectroscopy  
Study of Radiofrequency-Sputtered  
Titanium Carbide, Molybdenum Carbide,  
and Titanium Boride Coatings  
and Their Friction Properties

William A. Brainard and Donald R. Wheeler

OCTOBER 1977

Lewis Research Center

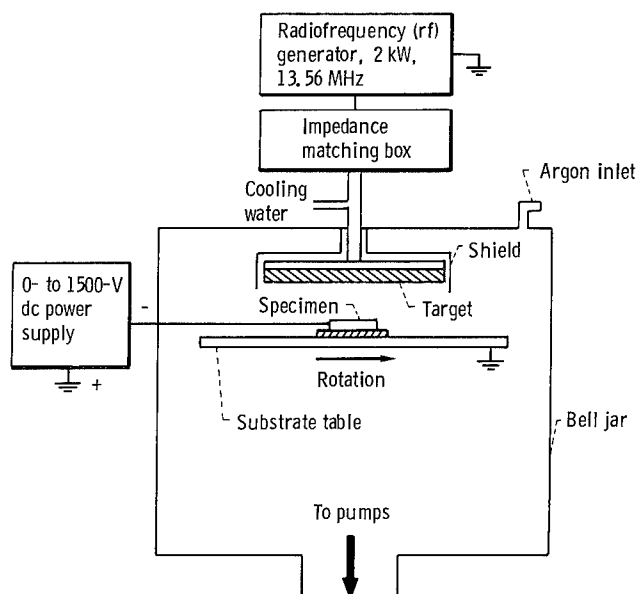
Figure 1. - Schematic of rf sputtering apparatus.

The sputtering of the materials used in this investigation was conducted in a commercial rf diode apparatus (fig. 1) operating at 13.56 megahertz. The material to be sputter deposited is in the form of a hot pressed compact which was commercially purchased. The specimen to be coated is placed 2.5 centimeters directly below the target on an electrically insulated block. An additional voltage from 0 to -1500 volts dc may be applied directly to the specimen either for specimen cleaning by dc sputter etching or for biasing the specimen during film deposition and growth. Provision is made for rotation

of the entire substrate table so the specimen may be moved out from under the target for cleaning. The target also can be cleaned in this manner without contaminating the specimen. The system is mechanically forepumped and oil diffusion pumped through a liquid nitrogen cooled baffle. During deposition, high purity argon (99.9995 percent) was bled continuously into the system through a leak valve and a dynamic pressure balance between the pumping system and argon leak of approximately 20 microns was maintained in the bell jar.

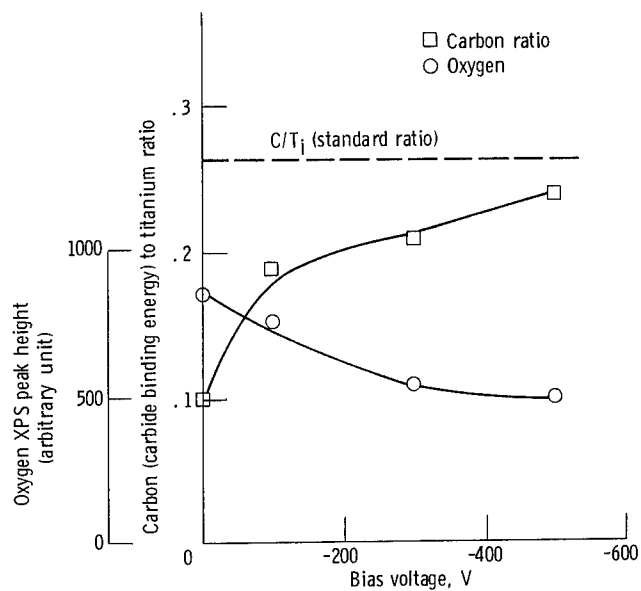
Figure 2. - Variation of oxygen (1s) XPS peak height and ratio of C(1s) to Ti(2p<sub>3/2</sub>) peak heights in sputtered TiC films as a function of substrate bias.

Figure 2 shows XPS data for sputtered TiC as a function of bias voltage. The composition closest to the standard (target material) and lowest oxygen concentration occurred at -500 volts, the same voltage as in the previous investigation (ref. 2). Figure 3 shows XPS peaks for the carbon (1s) and titanium ( $2p_{3/2}$ ) peaks at the two extremes of bias. As was observed in reference 3 for  $\text{CrB}_2$  and  $\text{MoSi}_2$  coatings, oxidation of one or both constituent elements has occurred with no external bias (grounded). The titanium oxide peak at 458.6 eV is large in the unbiased sample in contrast to the much smaller peak at -500-volt bias. This is evidenced in the figure by the filling in of the "valley" between the titanium doublet peak. In addition, the carbon peak at 285 eV for the 0-volt sample shows that, because of the formation of  $\text{TiO}_2$ , the carbon normally combined as carbide is in the free state. This accounts for the much lower carbide to titanium ratio without bias in figure 2, and partially explains the reported poorer friction performance of sputtered TiC coatings done without bias (ref. 2).

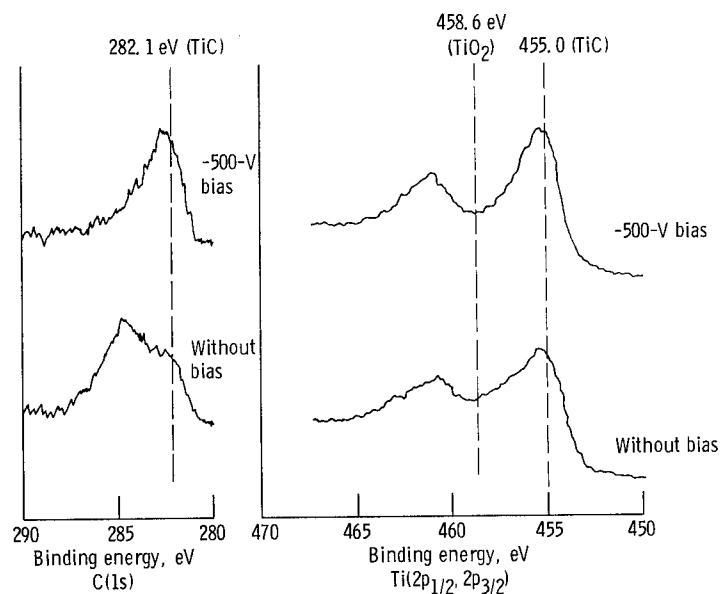
Figure 3. - Representative C(1s) and Ti(2p) XPS peaks from biased and unbiased TiC sputtered coatings.

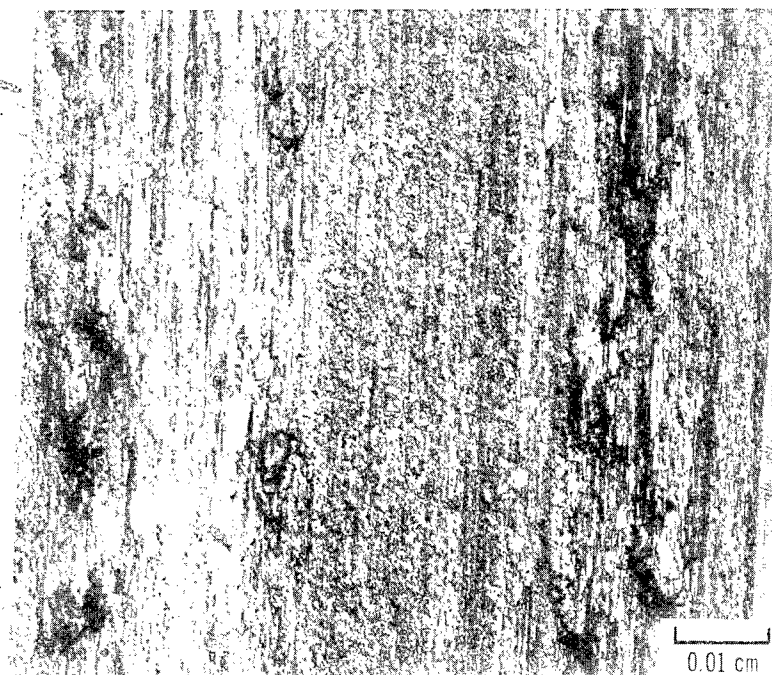
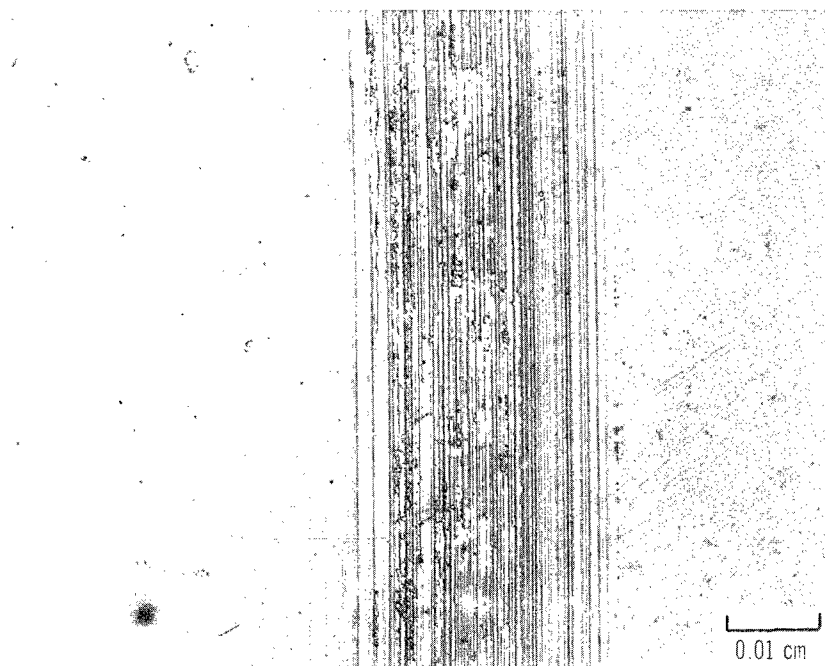
(a) 10% H<sub>2</sub>-90% Ar.

(b) 100% Ar.

Figure 4. - Disk wear tracks for 440-C disk rf sputter coated with TiC ( -500-V bias); rider, 304 stainless steel; load, 0.25 newton; sliding time, 30 minutes.

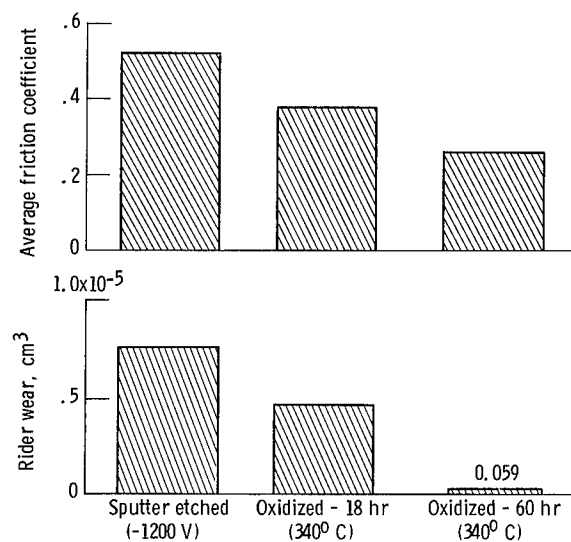
Figure 5. - Average friction coefficient and rider wear for 440-C disks rf sputter coated with TiC (-500-V bias); rider, 304 stainless steel; load, 2.0 newtons; sliding time, 60 minutes;  $N_2$  atmosphere.

tion of an oxidized layer. No attempt was made to measure the oxide thickness or determine its composition. Figure 5 presents friction and wear data for TiC rf sputtered onto 440-C disks, one disk having been sputter etched at -1200 volts for 15 minutes to remove the normal oxidized layer, another deliberately preoxidized for 18 hours and the third preoxidized for 60 hours. The coatings were all applied under the same sputtering conditions. The results are clear. Lower friction and wear were obtained with TiC on the preoxidized substrates. These results are directly related to improved film adherence. Figure 6 shows surface profile tracings on the wear track on TiC coated 440-C at a 5-newton load for a sputter etched disk and preoxidized disk. The results are dramatic and represent a significant exception to the usual concept of a need for a rigorously precleaned surface prior to coating.

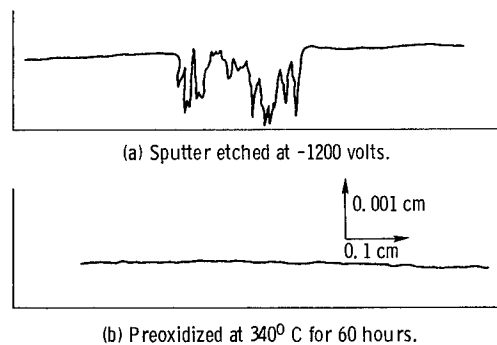
Figure 6. - Surface profile tracings of disk wear track for 440-C disk rf sputter coated with TiC (-500-V bias); load, 5 newtons; sliding time, 60 minutes;  $N_2$  atmosphere.

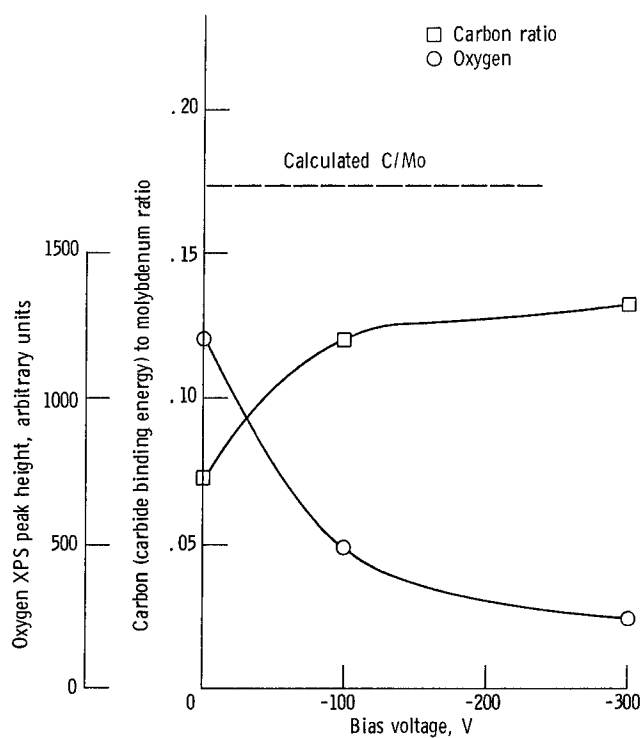
Figure 7. - Variation of oxygen (1s) XPS peak height and ratio of C(1s) to Mo(3d<sub>5/2</sub>) XPS peak heights in sputtered Mo<sub>2</sub>C films as a function of substrate bias voltage.

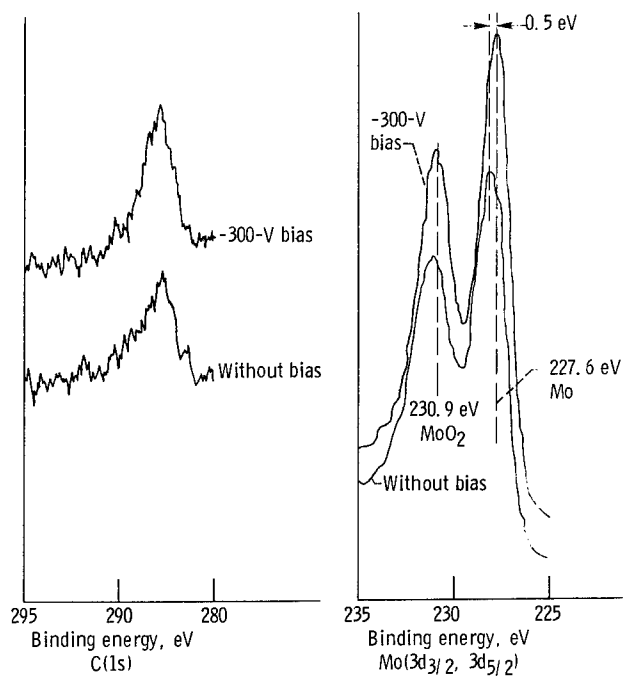
Figure 8. - Representative C(1s) and Mo(3d) XPS peaks from biased and unbiased Mo<sub>2</sub>C sputtered coatings.

Figure 8 shows the  $\text{C}(1s)$  and  $\text{Mo}(3d_{3/2}, 3d_{5/2})$  peaks taken from coating samples done at -300 volts and without bias. The size difference between the two molybdenum peaks for the two bias conditions are significant. The shift of the Mo peak without bias toward higher binding energy is very small (0.5 eV) but large enough to be greater than the instrumental error ( $\pm 0.3$  eV). The presence of a peak shifted to higher binding energy is confirmed by the filling in of the valley between the two Mo(3d) peaks in the unbiased case. A 0.5-eV shift has been observed previously on Mo foils exposed to air. We conclude that the shift is due to oxidation of the molybdenum yielding films that are really mixtures of oxides and carbides. Biasing at -300 volts significantly reduces the oxide yielding films with only about one-fifth the oxygen of films prepared without bias.

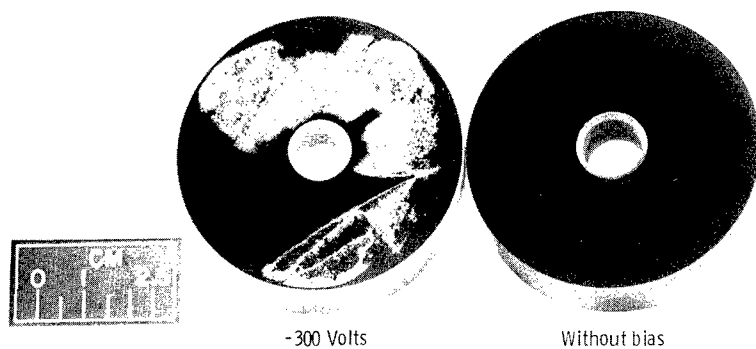
Figure 9. - Two 440-C disks sputter coated with  $\text{Mo}_2\text{C}$  at two bias conditions (disks precleaned by sputter etching at  $-1200\text{ V}$  for  $15\text{ min}$ ).

Sputter etched (-1200 V for 15 min) 440-C disks were coated with  $\text{Mo}_2\text{C}$  with no bias and -300 volts bias in order to determine the changes in the friction properties due to biasing. Figure 9 is a photograph of those two specimens after coating. The sample done at -300 volts was flaky. The film blistered (fig. 10) and subsequently peeled off due to the internal stresses in the film. Several other samples were prepared with similar results. XPS analysis of the 440-C surface after the coating peeled off showed

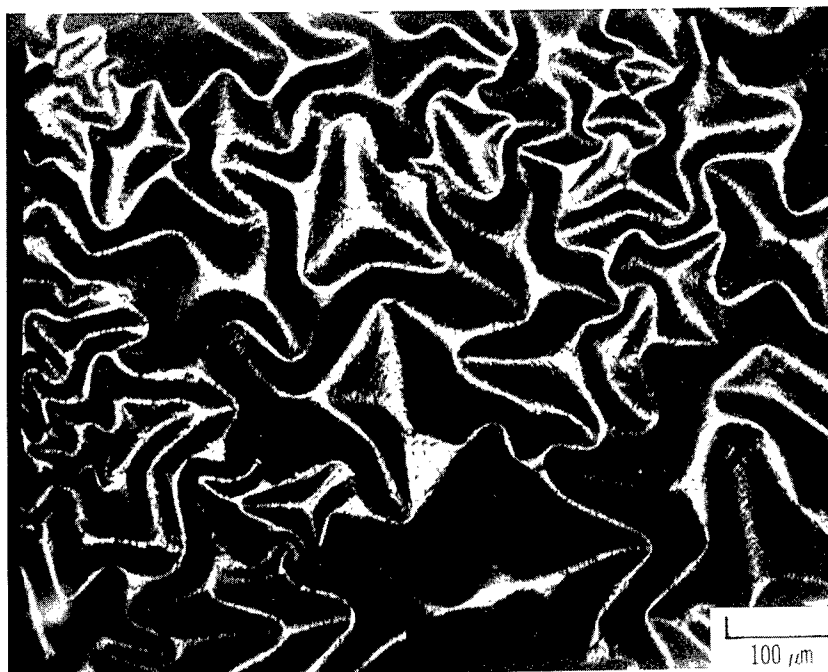
Figure 10. - Photomicrograph of surface of 440-C disk rf sputter coated with  $\text{Mo}_2\text{C}$  ( $-300\text{-V}$  bias). Disk sputter etched ( $-1200\text{ V}$  for  $15\text{ min}$ ) prior to coating.

no molybdenum remaining indicating that coating failure occurred at the interface itself. Depositing a coating with minimum oxygen impurity level (-300-V bias) onto a sputter etched disk produced extremely poor adherence. No friction data was taken on the samples done at -300 volts because of the obviously poor adherence and friction for the unbiased sample was high because of the poor bulk film quality. It was felt, based on the results with TiC, that oxides at the interface were important in achieving good adherence, and biasing and sputter etching worked to reduce that oxide formation. Figure 11 shows the effect on friction and film wear if a growing film is allowed to form an oxidized surface before any bias voltage is applied. The first 2 minutes of deposition were done without bias after which -300 volts was applied. This yielded an oxidized interface but still a high quality bulk film. The contrast in friction and film wear are conclusive. Also shown in figure 10 is friction and surface profile wear tracings for  $\text{Mo}_2\text{C}$  sputtered onto oxidized 440-C (20 hr at  $340^\circ\text{C}$ ). The reduction in friction is the same as for the varied bias sample. In both cases, no wear track could be observed in the profile tracings done at high vertical magnification.

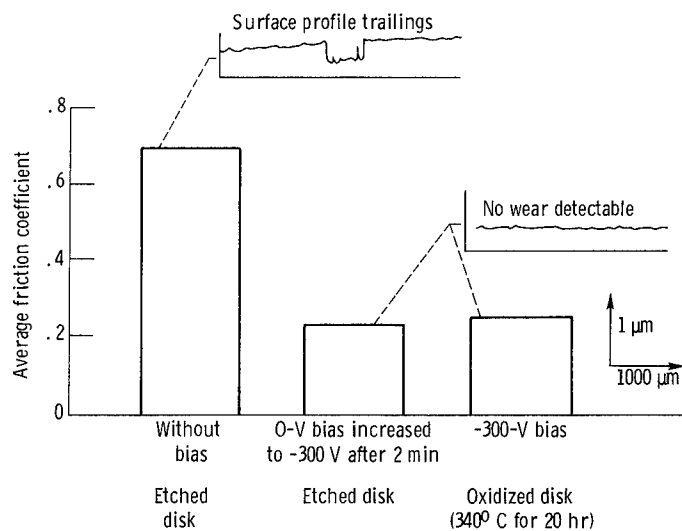
Figure 11. - Average friction coefficient and coating wear traces for 440-C disk rf sputter coated with  $\text{Mo}_2\text{C}$ ; rider, 304 stainless steel; load, 0.10 newton; sliding time, 30 minutes;  $\text{N}_2$  atmosphere.

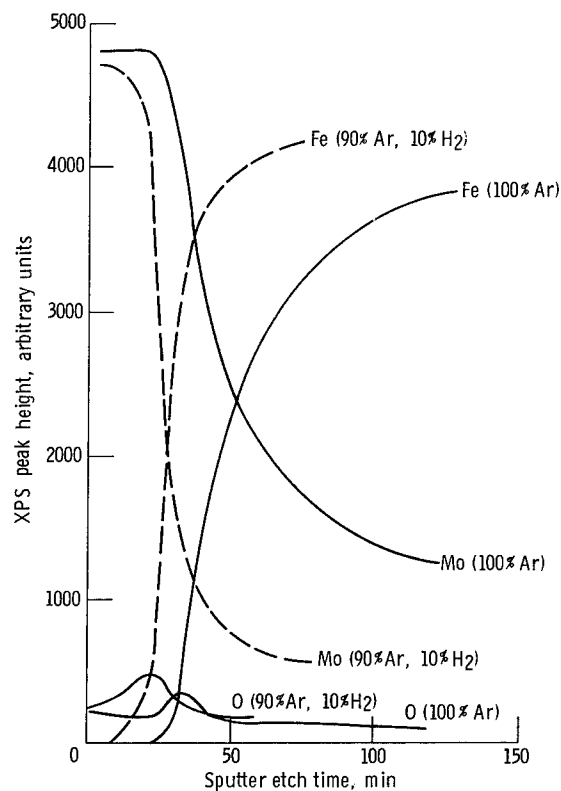
Figure 12. - Variation of Mo, Fe, and  $\text{O}_2$  concentration with sputtering time for two  $\text{Mo}_2\text{C}$  sputtered coatings (-300-V bias).

In order to further verify the importance of interfacial oxide formations in adherence of  $\text{Mo}_2\text{C}$ , samples were prepared for depth profile studies. The two samples were both sputtered at -300 volts bias, however, one sample was prepared with 10 percent hydrogen added to the argon supply in an attempt to reduce interfacial oxides. Each sample was analyzed by XPS while the film was slowly etched away by argon ion bombardment. The results, summarized in figure 12, are very definitive. The interface, when hydrogen is present, is very sharp while the interface of the sample done in pure argon is broad and graded. The sputtering rate was estimated to be approximately  $20\text{ \AA}/\text{min}$ . Based on sputter etching time, this means that the graded interface is perhaps greater than  $2500\text{ \AA}$ , much larger than would be anticipated for a sputtered film interface based on arrival energies. The oxygen content of both films is low. This is undoubtedly due to the substrate bias. Each sample shows an oxygen peak increasing to a maximum during etching and then decreasing as the molybdenum peak decreases. Both films exhibited very poor adhesion in spite of the great difference in interface thickness. Apparently, the presence of metal oxide is crucial to good film adhesion, no matter what the interface thickness is.

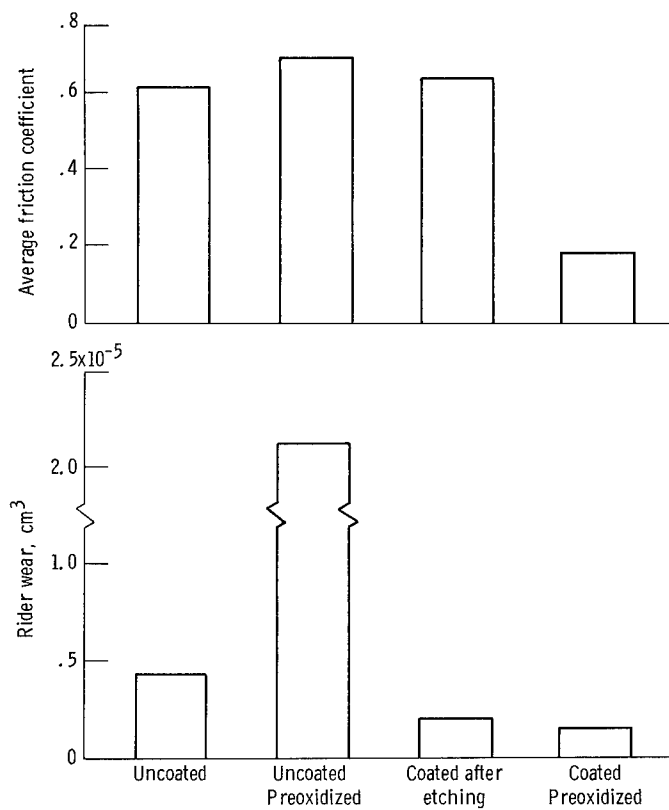
Figure 13. - Average friction coefficient and rider wear for 440-C disks either sputter etched ( $\sim 1200$  V for 15 min) or oxidized (20 hr at  $340^\circ$  C). Coated disks are rf sputtered with  $\text{TiB}_2$  ( $\sim 300$ -V bias); load, 0.5 newton; sliding time, 30 minutes;  $\text{N}_2$  atmosphere.

Note in figure 13 that deliberately oxidizing the 440-C for 20 hours at  $340^\circ\text{C}$  produced an increase in friction over the unoxidized sample and a fivefold increase in rider wear. The increase in wear and, to some extent friction, no doubt is related to the formation of hard metallic oxides (e.g.,  $\text{Cr}_2\text{O}_3$  and  $\text{Fe}_2\text{O}_3$ ).

The  $\text{TiB}_2$  coated 440-C sample which had been cleaned by sputter etching prior to deposition showed some decrease in wear but no decrease in friction. Analysis of those films showed extensive spalling. Coatings deposited on oxidized surfaces (20 hr at  $340^\circ\text{C}$ ) showed very low friction ( $\sim 0.20$ ) and a further 25 percent reduction in wear. It also must be noted that, as with  $\text{TiC}$ , oxidizing the 440-C disks for a longer period might be expected to further improve the friction properties. In any event, the results clearly show that the reduction in friction and wear is due to the combination of disk oxide and the  $\text{TiB}_2$  coating. Either alone does not reduce friction.
